DEPARTMENT OF TRANSPORTATION

Quality Assurance and Source Inspection

Contract #: 04-0120F4Cty: SF/ALA Rte: 80 PM: 13.2/13.9File #: 1.28**WELDING INSPECTION REPORT****Resident Engineer:** Casey, William**Address:** 333 Burma Road**City:** Oakland, CA 94607**Report No:** WIR-028811**Date Inspected:** 27-Nov-2012**Project Name:** SAS Superstructure**OSM Arrival Time:** 700**Prime Contractor:** American Bridge/Fluor Enterprises, a JV**OSM Departure Time:** 1730**Contractor:** American Bridge/Fluor Enterprises, a JV**Location:** Job Site**CWI Name:** See below.**CWI Present:** Yes No**Inspected CWI report:** Yes No N/A**Rod Oven in Use:** Yes No N/A**Electrode to specification:** Yes No N/A**Weld Procedures Followed:** Yes No N/A**Qualified Welders:** Yes No N/A**Verified Joint Fit-up:** Yes No N/A**Approved Drawings:** Yes No N/A**Approved WPS:** Yes No N/A**Delayed / Cancelled:** Yes No N/A**Bridge No:** 34-0006**Component:** OBG**Summary of Items Observed:**

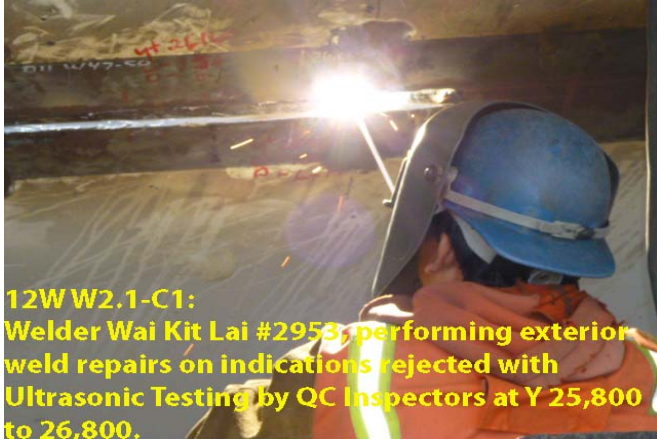
Welder was observed performing R1 exterior weld repairs on weld 12W W2.1-C1 indications rejected with Ultrasonic Testing (UTSW) by QC Inspectors between Y 25,800 and 26,800. Welder was observed utilizing Welding Procedure Specification (WPS) ABF-WPS-D15-1000 Repair for Shielded Metal Arc Welding (SMAW). Welder was observed preheating the weld prior to welding. Welding parameters as verified by QC Inspector William Sherwood appear to be in compliance with the WPS noted above. Weld sections at Y 18,600 to 31,000 is non SPCM, a "Request for Weld Repair" or (RWR) is not required for R1 repairs.

12W W2.1-C1:
Welder Wai Kit Lai #2953, performing exterior
weld repairs on indications rejected with
Ultrasonic Testing by QC Inspectors at Y 25,800
to 26,800.

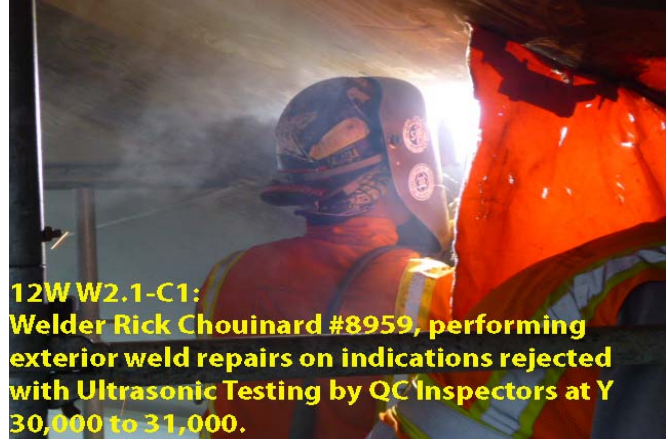
Welder was observed performing R1 exterior weld repairs on weld 12W W2.1-C1 indications rejected with Ultrasonic Testing (UTSW) by QC Inspectors between Y 30,000 and 31,000. Welder was observed utilizing Welding Procedure Specification (WPS) ABF-WPS-D15-1000 Repair for Shielded Metal Arc Welding (SMAW). Welder was observed preheating the weld prior to welding. Welding parameters as verified by QC Inspector William Sherwood appear to be in compliance with the WPS noted above. Weld sections at Y 18,600 to 31,000 is non SPCM, a "Request for Weld Repair" or (RWR) is not required for R1 repairs.

12W W2.1-C1:
Welder Rick Chouinard #8959, performing
exterior weld repairs on indications rejected
with Ultrasonic Testing by QC Inspectors at Y
30,000 to 31,000.
